HYUNDAI NEW THINKING. NEW POSSIBILITIES. Technical Service Bulletin		GROUP AUTOMATIC TRANSMISSION	NUMBER 14-AT-003
		DATE FEBRUARY, 2014	MODEL Tucson (LM), Santa Fe (CM/AN/NC), Sonata (YF/YF-HEV), Elantra (UD/MD/GD/JK), Accent (RB), Azera (TG/HG), Veloster Turbo (FS)
SUBJECT:	AUTOMATIC TRANSAXLE SOLENOID DTC P0741, P0743, P0748, P0753, P0758, P0763, P0768, P0773, P1778 & P2709

This TSB supersedes bulletin 13-AT-008 to revise the Service Procedure, Steps 5, 19, 28 and 29.

Description: Do not replace the transmission for solenoid DTC listed above. Instead, follow the repair procedure and replace the related part.

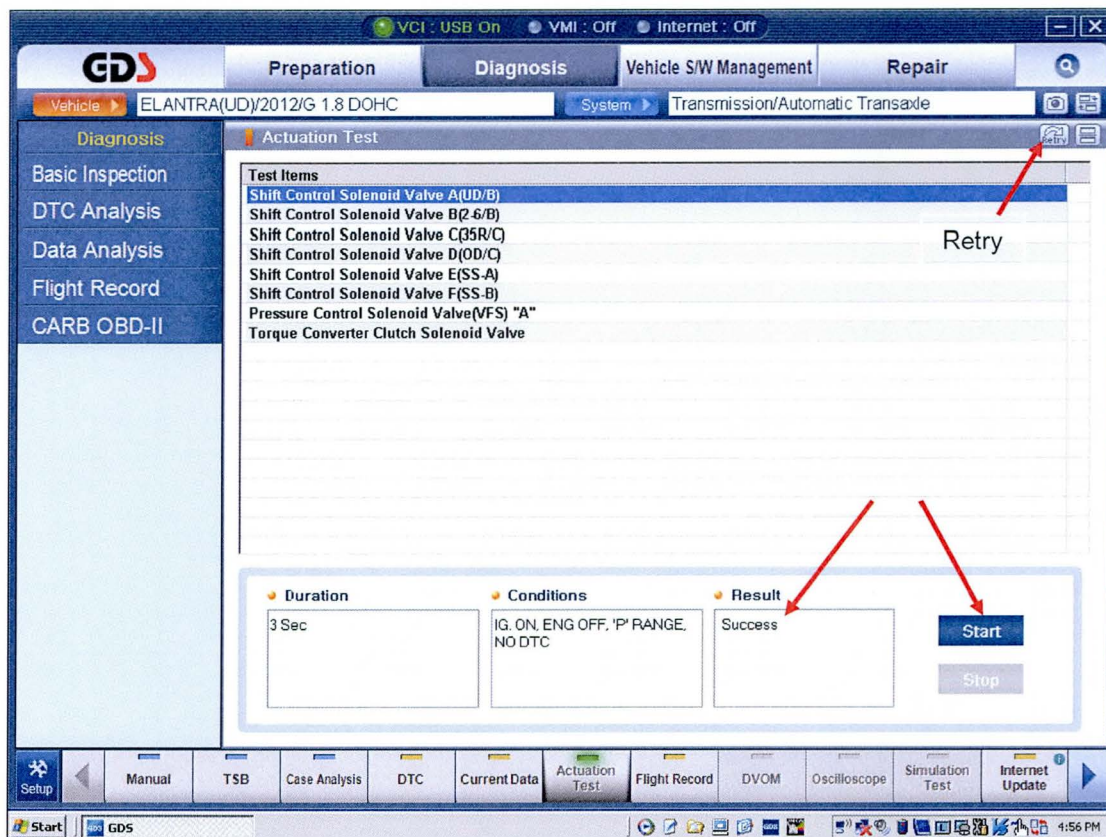
1. Using a GDS, check for DTC in the “Automatic Transaxle” menu. **Record the DTC and description.** Delete the DTC.
2. From the GDS, select the following parameters.
 - Vehicle and A/T menu.
 - “Actuation Test”

Press the “Start” button and look for a “Success” indication.

3. If the test results show:
 - “Success” – The GDS requested the TCM to activate the solenoids. Use chassis ears or stethoscope to listen for solenoid operation. If the solenoids are audible, the harness currently has no open/short circuit. Go to Step 5.
 - “Failure” - The GDS did not request the TCM to activate the solenoids. Click on the “Retry” button on the top right of the screen. If “Failure” is displayed again, go to Step 4.
4. Visually check the wiring harness between the PCM and transmission for a damaged wire or short circuit to ground. Check for a damaged pin or pin not fully inserted into the connector.
 - If damage exists, repair or replace the ECM control harness and drive the vehicle to confirm the repair.
 - If not, go to Step 5.

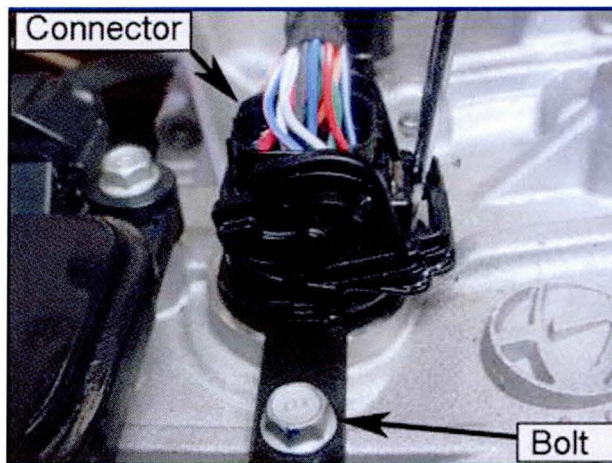
9. Use a screwdriver to release the tab and remove the solenoid connector on top of the case.

Remove the bolt that secures the connector and push the connector into the transmission.

Disconnect the vent hose on the top of the oil pan.

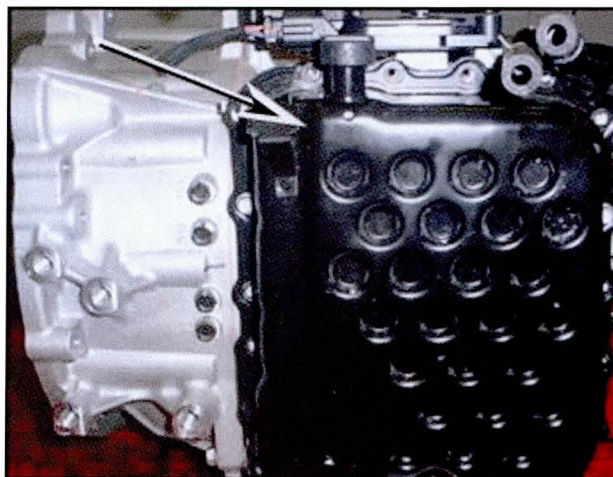
10. Remove the oil pan bolts and remove the pan.

Use rubber hammer to tap the oil pan cover on a corner until the cover is loose.

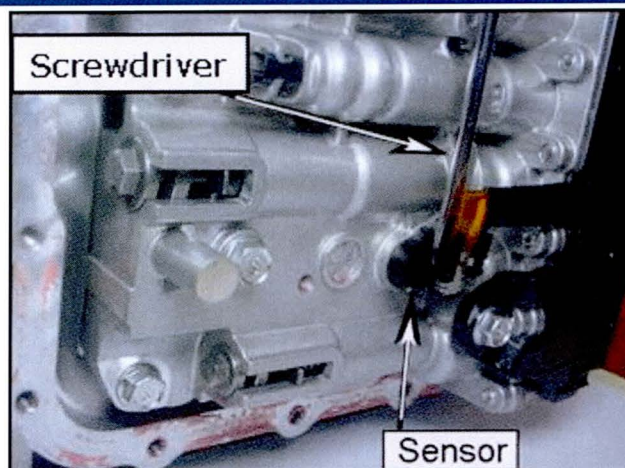
11. Use a small screwdriver to pry the connector from the oil temperature sensor (remove the sensor for vehicles with unified temperature sensor and harness).

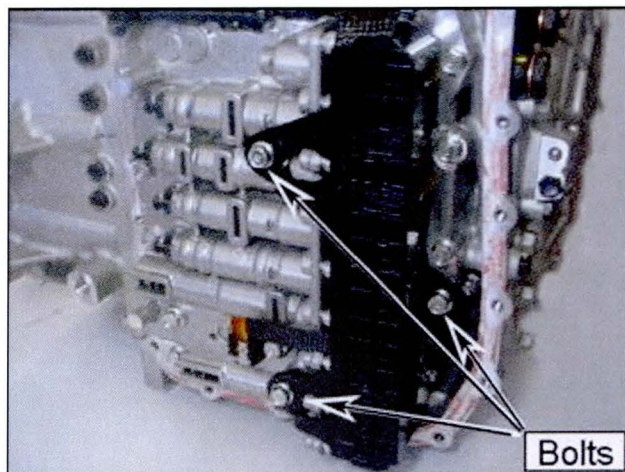
12. Remove three bolts to the solenoid valve connector.

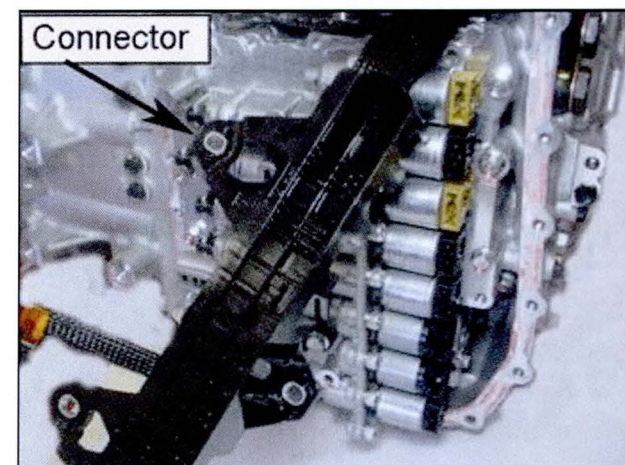
13. Pull the solenoid connector outward and move the connector out of position.

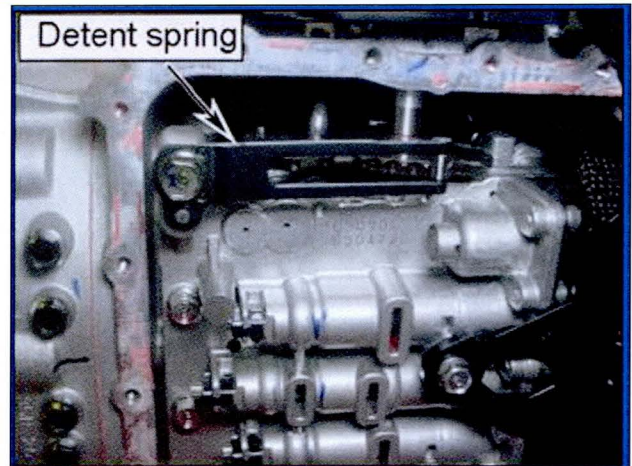
14. Remove the bolt that secures the detent spring and remove the spring.

Torque: 8~11 lb.ft (1.2~1.6 kgf.m)

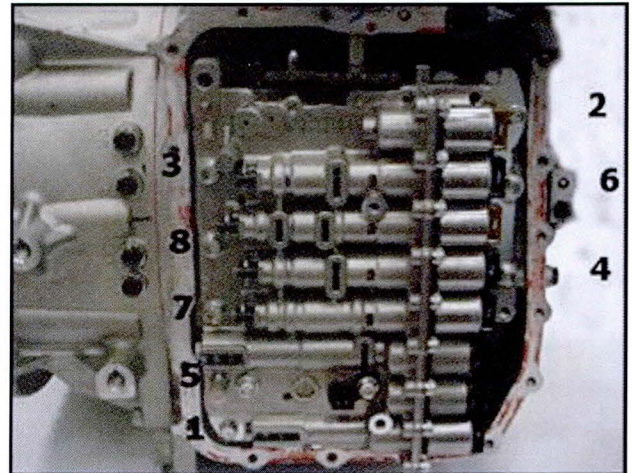
15. Remove the valve body bolts in the order shown and remove the valve body.

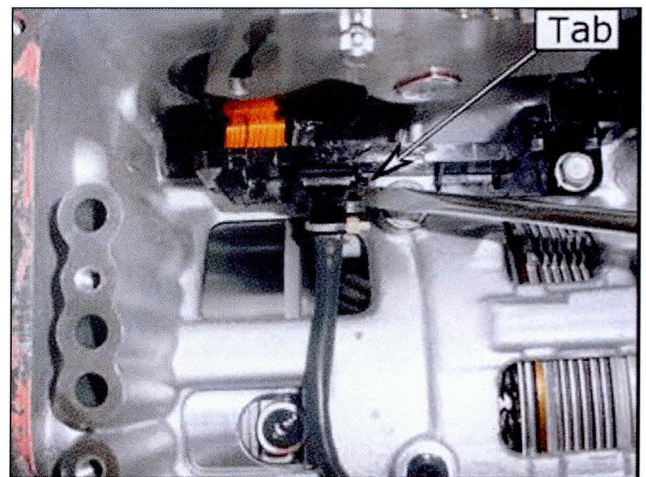
16. Use a screwdriver to depress the locking tab and pull outward on the connector to the input and output speed sensor.

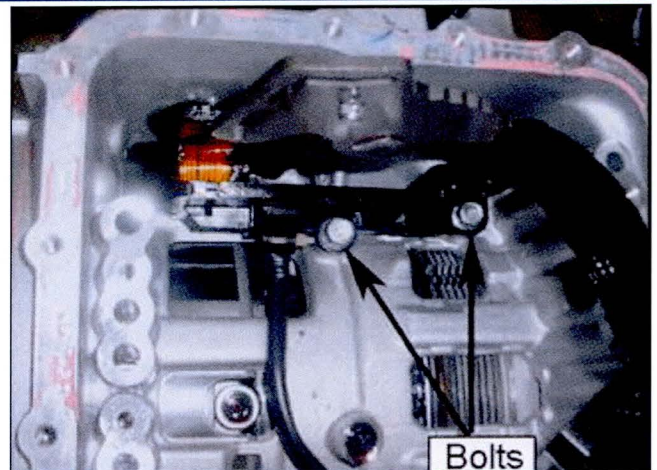
17. Remove two bolts that secure the valve body harness to the case.

Pull the connector downward out of the case.

Install a new harness and insert the connector into the case. Attach the retainer and bolt on top of the case as shown in Step 9.

Install the bolts that secure the harness.

Torque: 7~9 lb.ft (1.0~1.0 kgf.m)

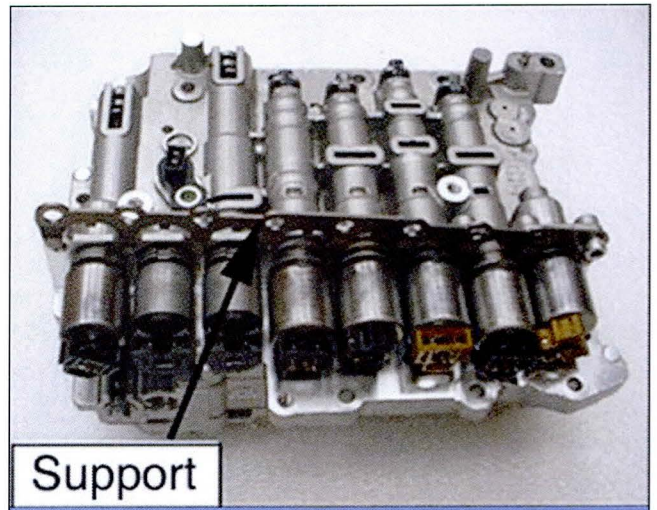
18. Use a 5mm hex socket and remove 9 Allen bolts that secure the solenoid support. Remove the solenoid support.

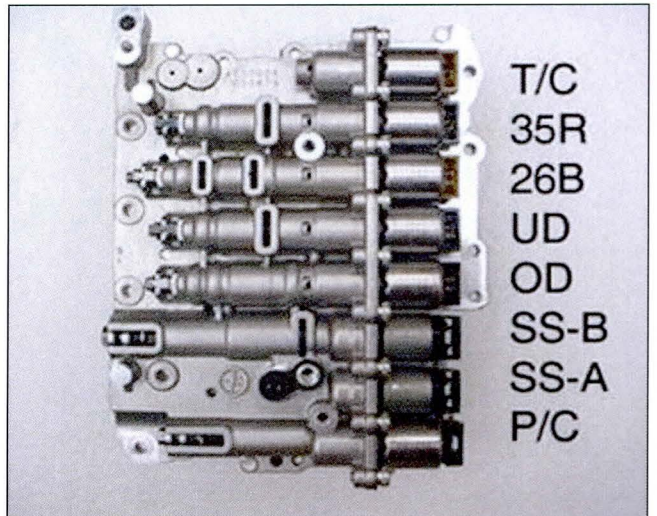
19. Refer to the DTC recorded in Step 1 and replace the related solenoid.

DTC		SOLENOID
P0741	T/C	TC solenoid (T/C)
P0743	T/C	TC solenoid (T/C)
P1778	T/C	HEV clutch solenoid
P0763	35R	Shift solenoid C (35R)
P0758	26B	Shift solenoid B (26-B)
P0753	UD	Shift solenoid A (UD)
P0768	OD	Shift solenoid D (OD)
P2709	SS-B	Shift solenoid F (SS-B)
P0773	SS-A	Shift solenoid E(SS-A)
P0748	P/C	P/C solenoid

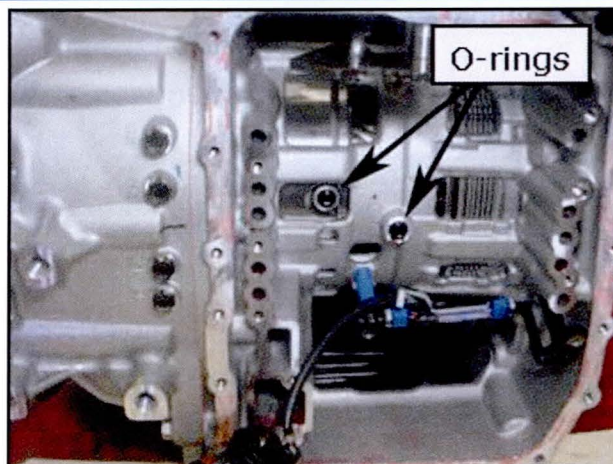
20. Confirm the O-rings are installed correctly in the case.

Reconnect the input and output speed sensor connector to the harness.

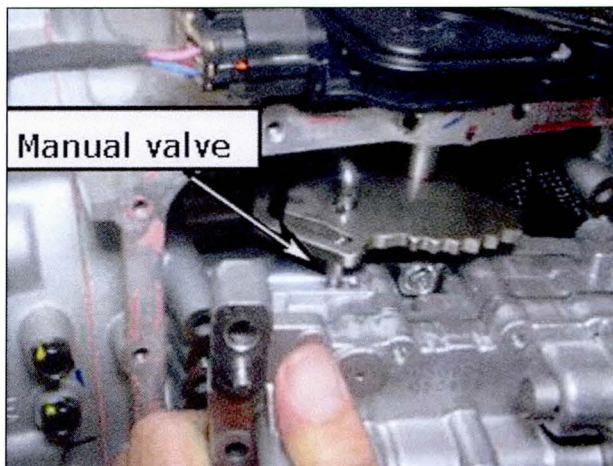
21. Align the manual shaft to the shift lever and install the valve body.

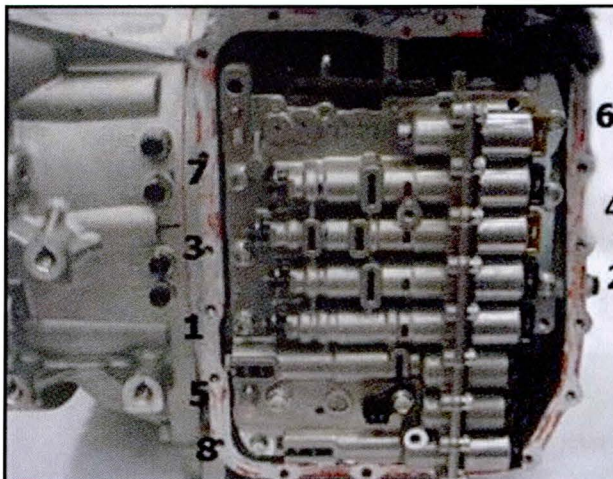
22. Install the valve body bolts and torque the bolts to specification in the order shown.

Torque: 7~9 lb.ft (1.0~1.2 kgf.m)

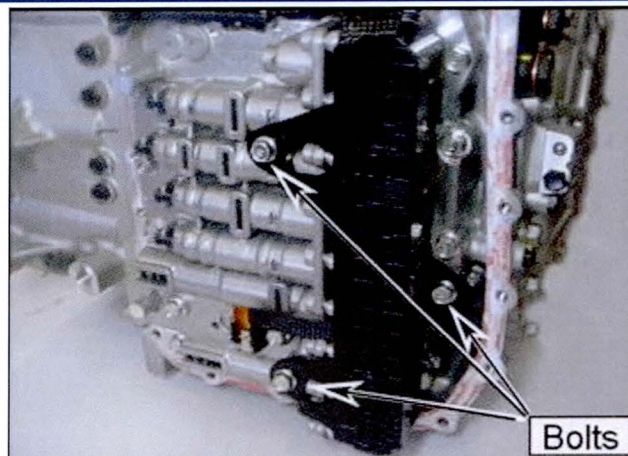
23. Reconnect the solenoid harness to the solenoids and oil temperature sensor.

Install the bolts to the solenoid harness connector and torque to specification.

Torque: 7~9 lb.ft (1.0~1.2 kgf.m)

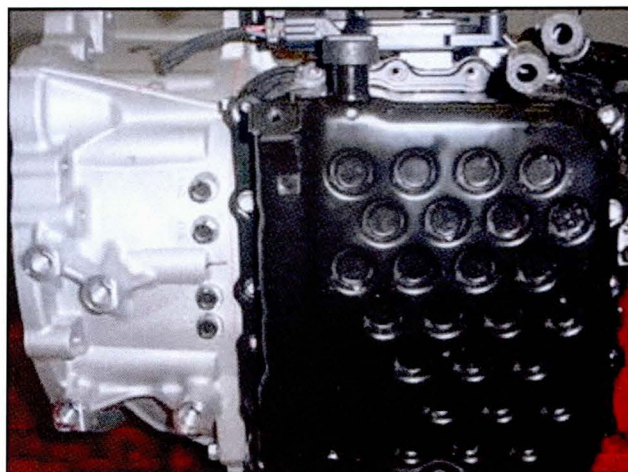
24. **STEEL OIL PAN:**

Apply Permatex Ultra Gray Sealer or Hyundai Ultra Gray Gasket Sealer, P/N 00232-19039, to the oil pan and reinstall the pan.

PLASTIC OIL PAN:

Install a new gasket to the oil pan and reinstall the pan.

Tighten the bolts to specification.

Torque: 10~12 lb.ft (1.4~1.6 kgf.m)

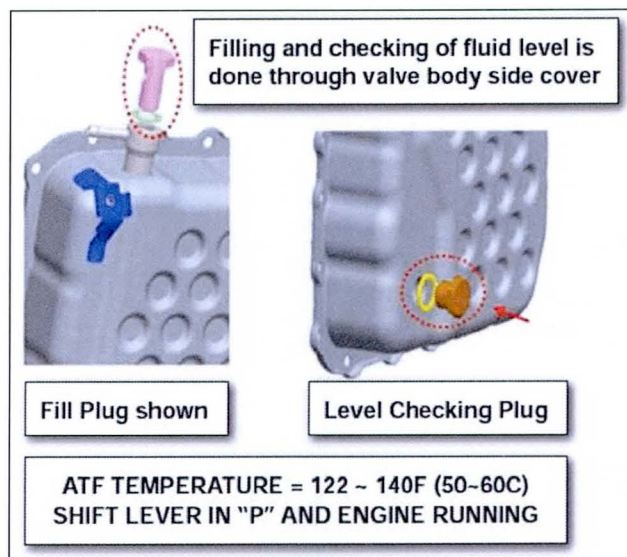
27. Remove the transaxle fill plug.

Use a funnel to add approximately 5~6 quarts of SPH-IV ATF through the fill plug opening. Reinstall the fill plug.

Attach the GDS to the DLC and select vehicle, A/T menu, Current Data and "Oil Temperature Sensor".

Start the engine and shift to Park. When the ATF is 122°F~140°F (50~60°C), remove the level checking plug. The level is correct when oil flows out of the level checking plug in a thin steady stream.

Collect and dispose of any excess fluid in accordance with local regulations.
